Miroslav Bidovský

Transport Research Centre, Brno, Czech Republic

First light barriers at level crossings in the Czech Republic

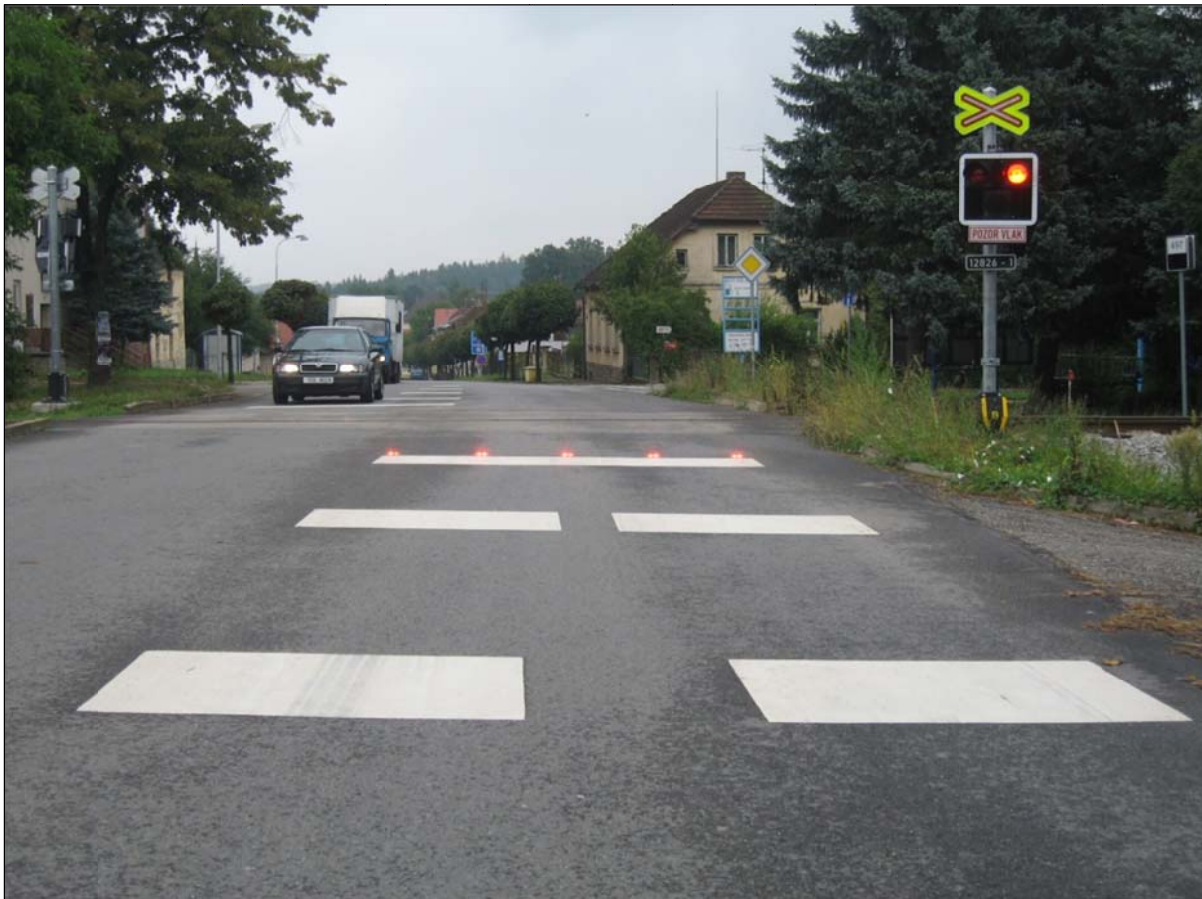
Making use of proceeding reconstruction, CDV carried out the installation of the light barrier as well as funneled psychological brake. Both measures improved the markedness of the level crossing significantly (see figure 3).

Figure 3. Light barrier and funneled psychological brake in Nová Včelnice

Since July 2011, visual checks of the device have been carried out regularly. The checks include functionality of the light barrier, physical state of all components (LED diodes shine, state of the studs – cracks or scratches on cover glass, waterproofing), state of the joint materials and fillers, state of the funneled psychological brake.

Until now, no functionality errors were identified. There were minor damages on the cover glasses of the studs due to winter maintenance (use of rough spreading), and at the end of the testing period, on LED diode ceased shining.

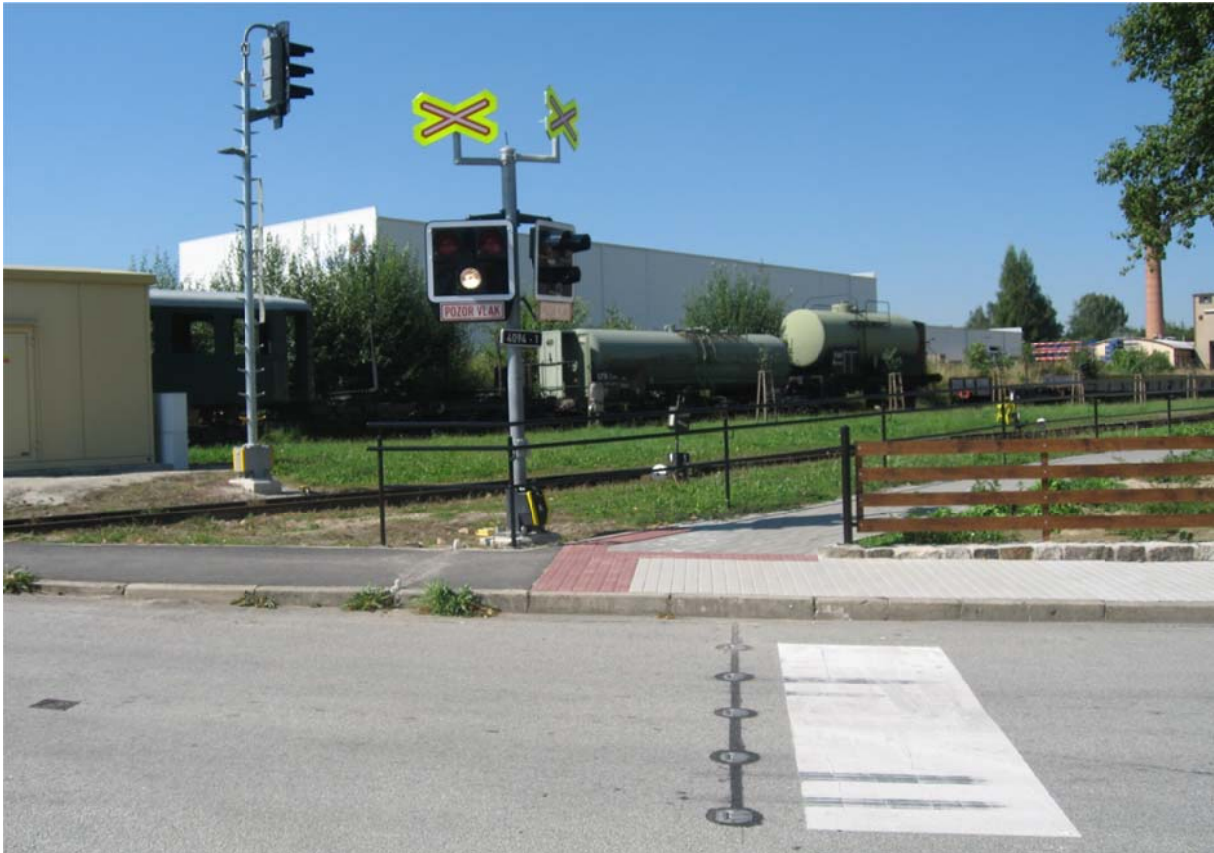
At the same railway, another pilot site was selected, in Kamenice nad Lipou. Situation of the level crossing was similar – originally equipped only with Andrew's cross and stop sign, later with warning lights, the crossing was still poorly visible in its surround, with bad view conditions. After success of the light barrier in Nová Včelnice, the management of the railway company initiated second installation here, in June 2013 (see figure 4).

Figure 4. Light barrier in Kamenice nad Lipou

The same criteria have been followed during visual checks at this site as in Nová Včelnice. Until now, no functional or technical defects appeared, and no accidents. The survey of public acceptance was carried out as a part of the testing (see chapter 2.5).

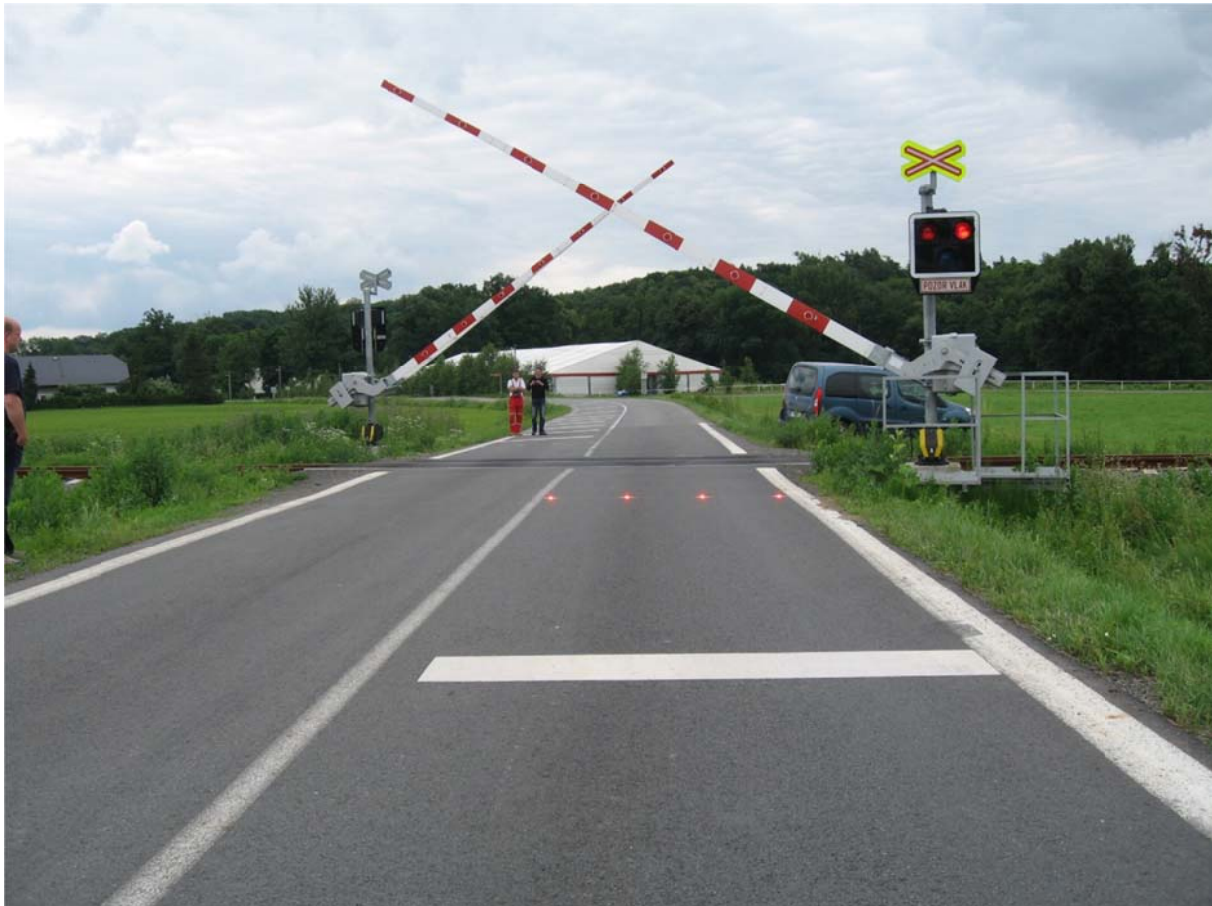
practically as the bypass of the town Opava. Although this crossing was not known as a black spot, expected increased road traffic induced the need of higher level of the level crossing protection, so it was equipped with warning lights and complementary mechanical barrier. As a part of the reconstruction, the administrator agreed with experimental installation of the light barrier (see figure 5). It was installed in September 2012 during the reconstruction, and, after complicated administrative proceedings, put into operation in June 2013.

Figure 5. Light barrier combined with additional mechanical barrier in Otice

Apart from regular checks of technical condition of the device (no malfunctions or defects until now), camera observations of behaviour of drivers before and after were carried out (see chapter 2.4).
