Young Researchers Seminar 2015
June 17 – 19, 2015
Rome, Italy

First Light Barriers at Level Crossings in the Czech Republic

This presentation contains mainly the results of the research project *SVEZA - Research on the applicability and effectiveness of the so-called light barrier at level crossings in the CR (2011 – 2014)*, carried out in cooperation with TRAKCE, under the financial support of the Technology Agency of the CR. Main goals: Define conditions (legal and technical) of application of the light barrier in the Czech Republic, set up 3 – 4 pilot applications at crossings with varied characteristics and using products of different producers, investigate impact of the light barrier on users' behavior, and carry out public acceptance research

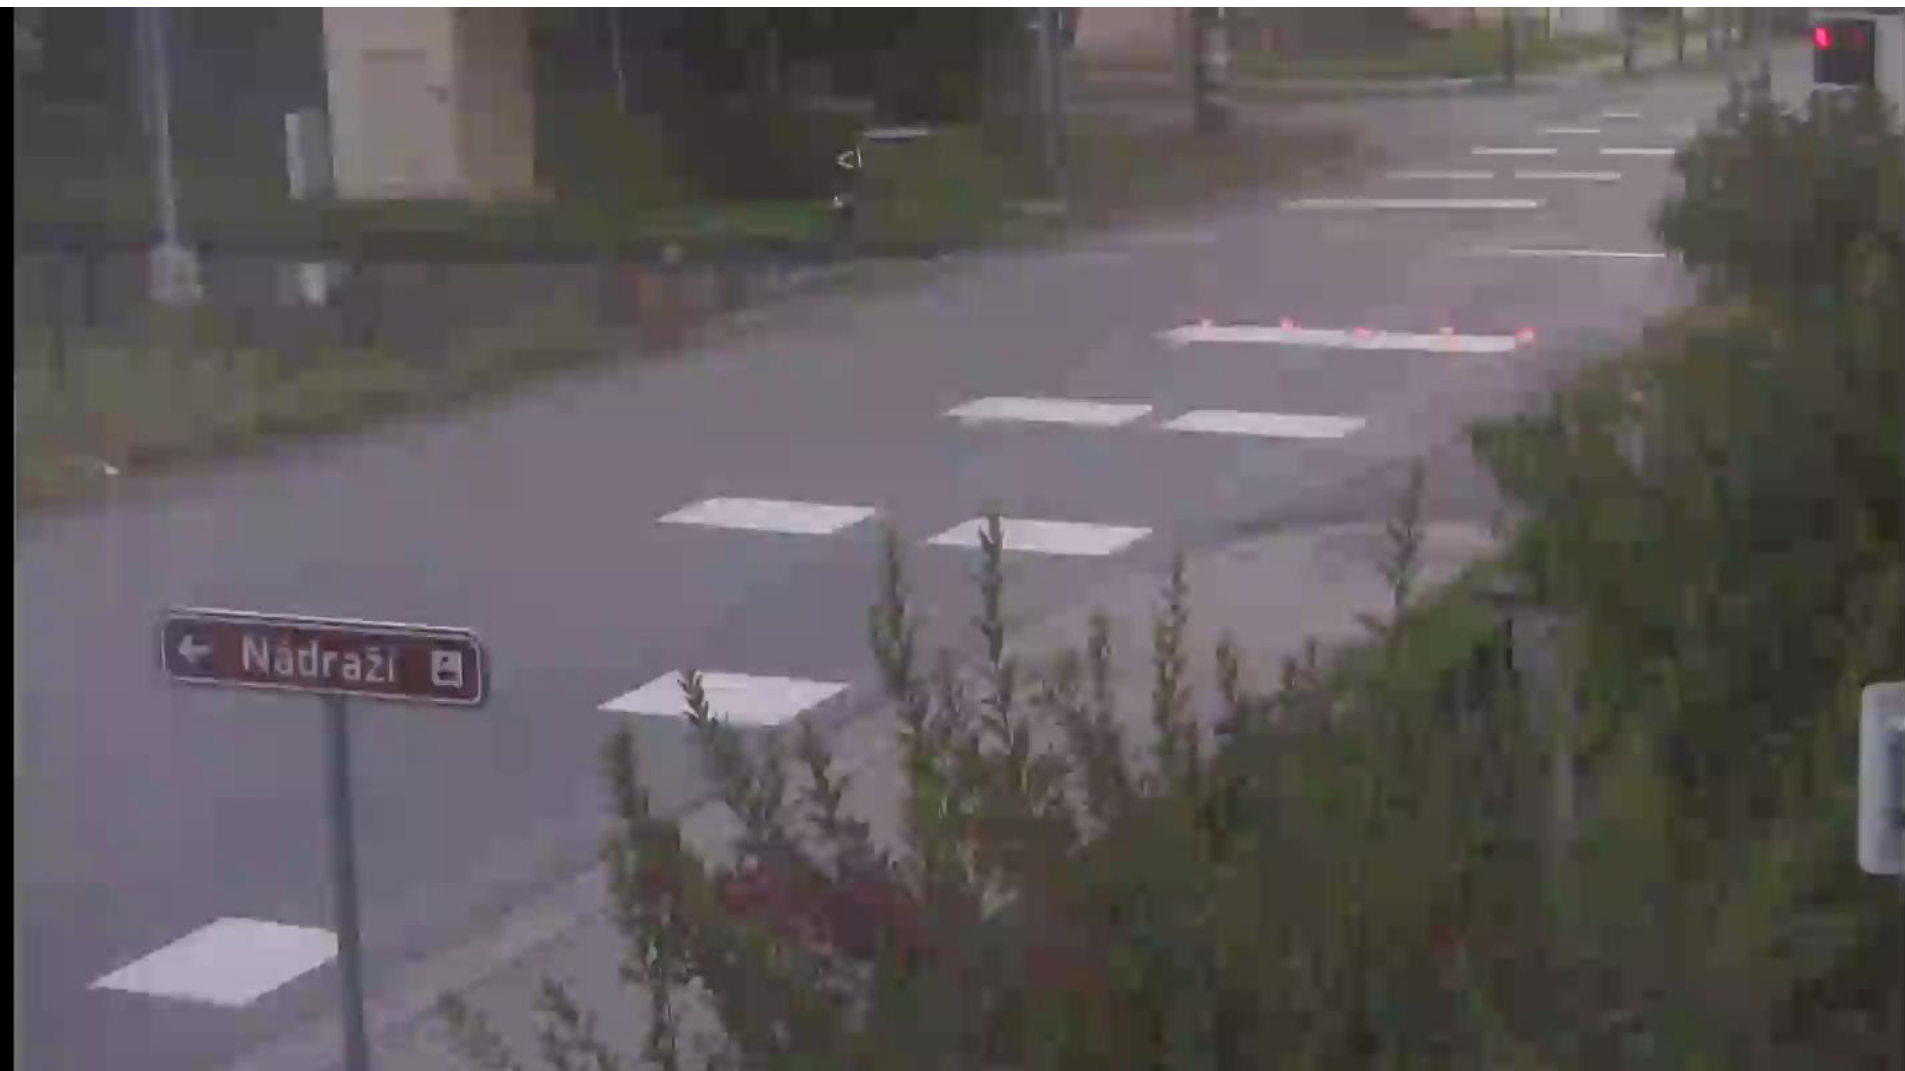
- The device consists of the set of red traffic light studs
- Studs light up flashing red lights simultaneously with the basic warning lights, creating optical barrier
- Activated by a non-potential contact of the crossing signaling device relay; any failure must not effect basic warning light device

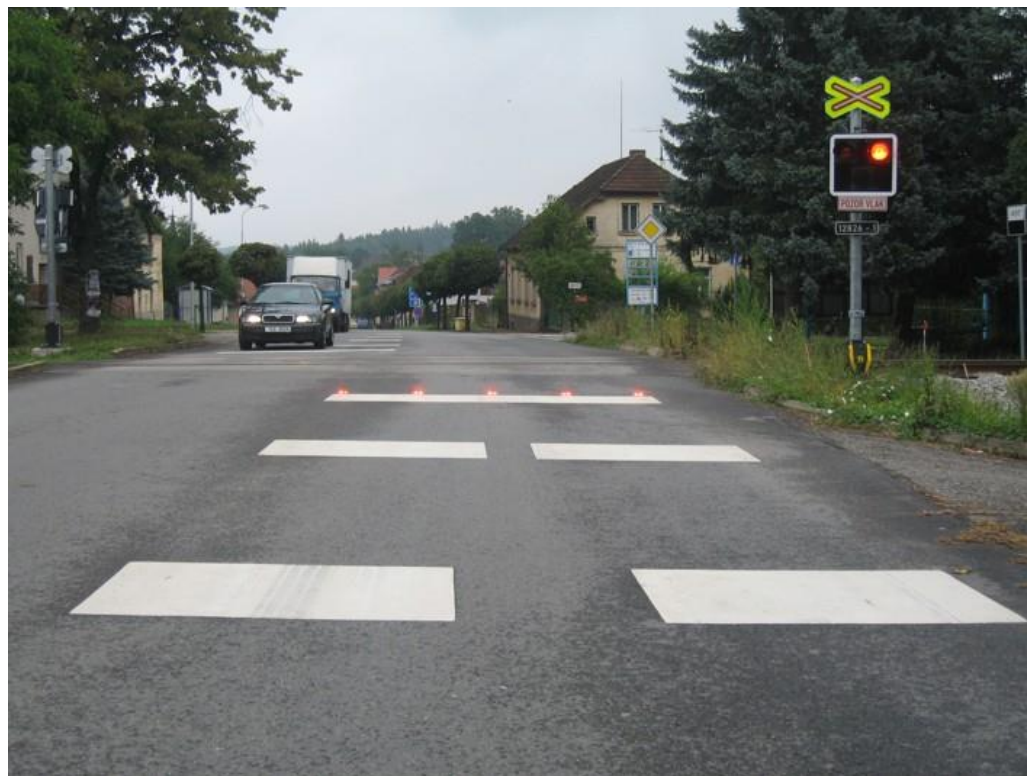
Pilot implementation in Nová Včelnice

- Installation June 2011, in operation since July 2011
- No accidents during the testing period
- Technical checks: no functionality errors identified until now, minor damages on cover glasses of the studs and deficiency of one LED diode
- Survey of public opinion, observation of road users' behavior, and measurement of luminance carried out

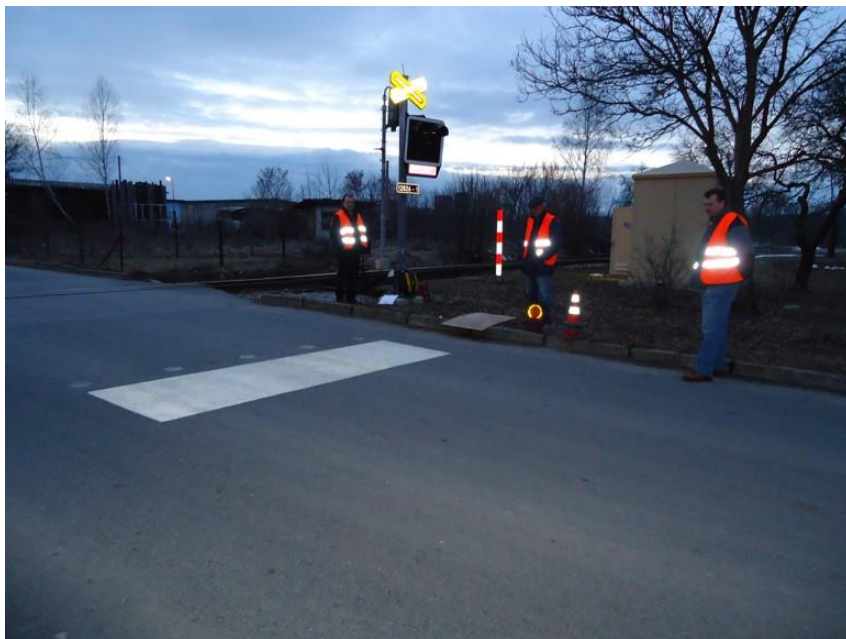
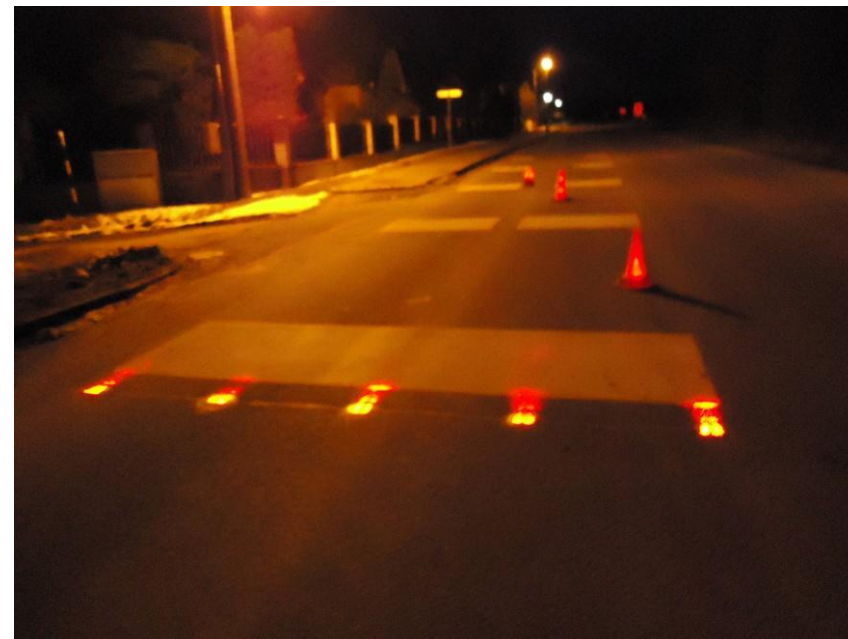
Measurement of luminance – example of results (in cd)

horizontal angle vertical angle	20°	15°	10°	5°	0°	5°	10°	15°	20°
15°		1.9	2.4	3.9	4.5	3.4	2.0	1.4	
10°	1.7	3.4	7.3	15.4	16.7	11.8	4.7	2.7	1.0
5°	2.7	8.2	23.2	66.0	79.1	51.8	16.7	5.1	1.3
2° 20'	3.1	10.6	33.5	84.0	113	69.5	25.3	5.9	1.5

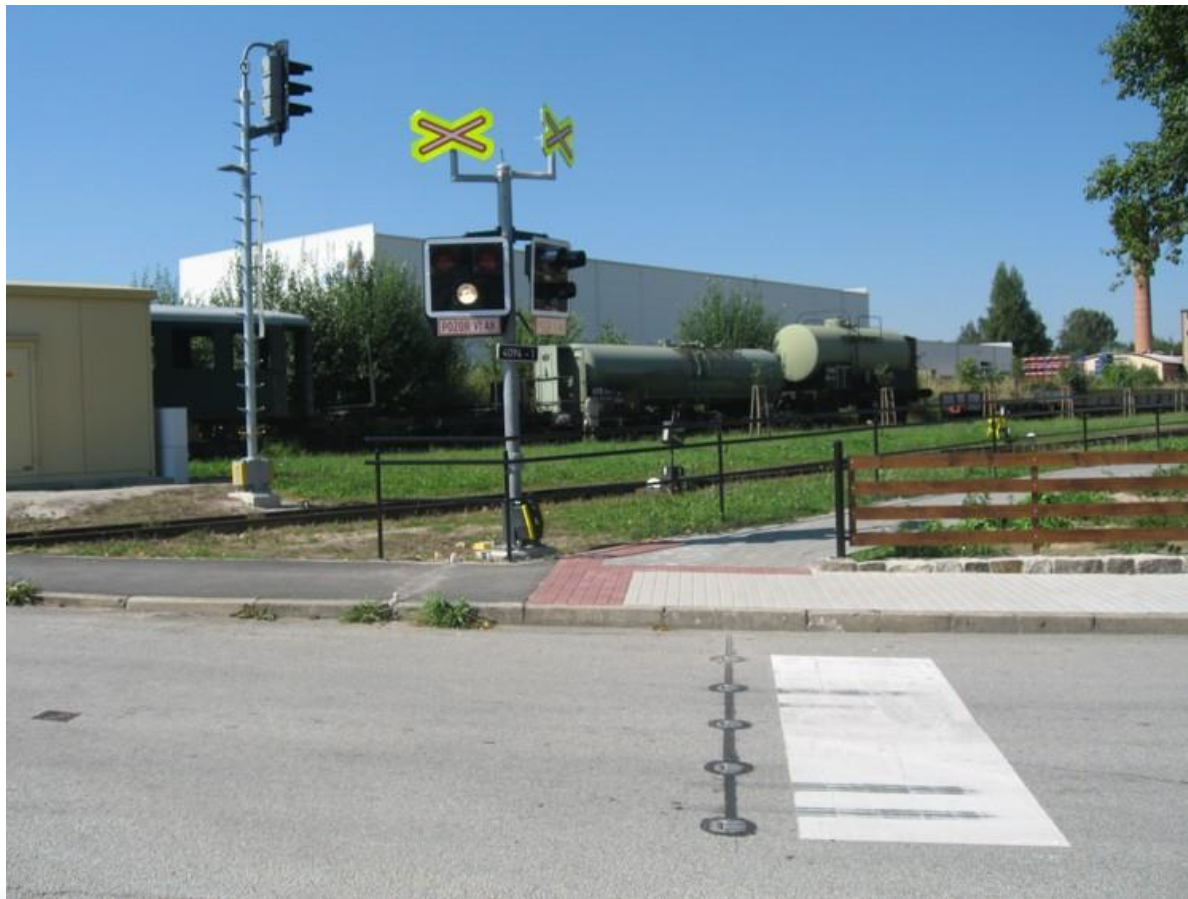
Pilot implementation in Kamenice nad Lipou

- Installation and start of operation in June 2013
- No accidents during the testing period
- Technical checks: neither functionality errors identified until now, nor technical defects
- Survey of public opinion was carried out at this site

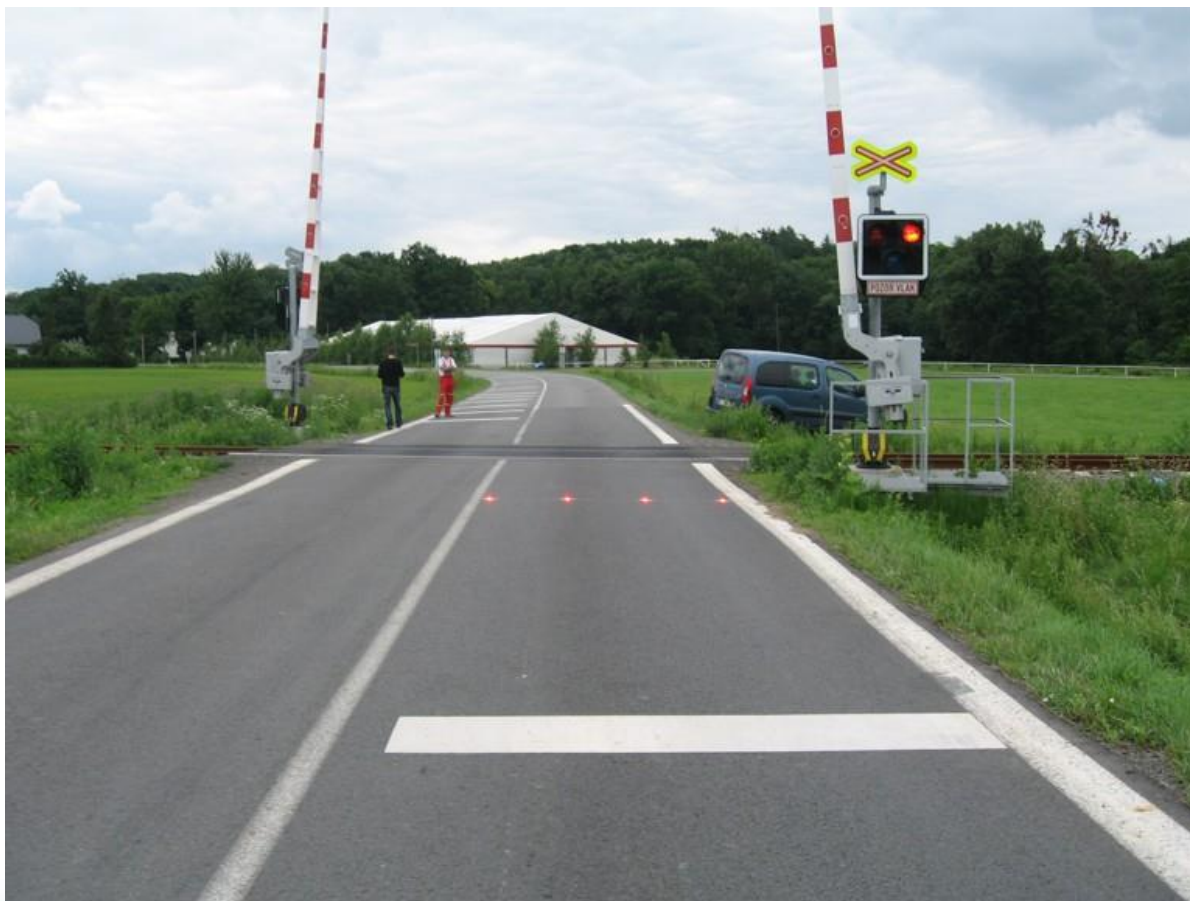
Pilot implementation in Otice

- Installation September 2012, start of operation June 2013; this installation required development of special convertor for plugging
- The level crossing is equipped with warning lights and complementary barriers; basic idea was to enhance the significance of the warning signal
- No malfunctions or defects until now
- Before/after observations of road users' behavior carried out
